# Community of Sambaa K'e Source Water Protection Plan

***March 2015***

**Prepared by:**  
Sambaa K'e Dene Band  
Ecology North

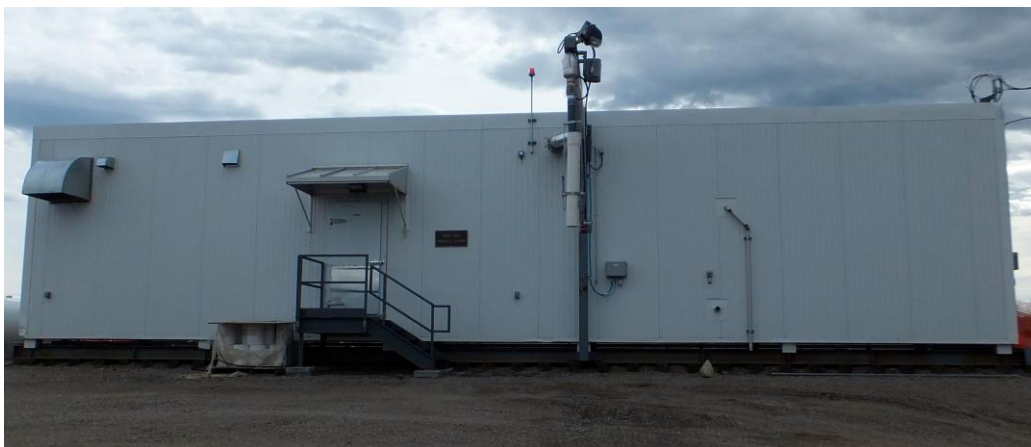
*Figure 6: Trout Lake Modular Water Treatment Facility*

The Smbaa K'e water treatment facility is located approximately 250 metres from Trout Lake, and about 0.5 km west of the community (see Figure 3). The current system, which was installed by Corix Water Systems in 2013, is comprised of an earthen fenced reservoir (Figure 4) and a modular plant that is approximately 5 metres by 19 metres (Figure 5). In contrast to the original treatment facility in Trout Lake that did not have a filtration system and relied solely on chlorination for treatment, the new system includes coagulation and membrane filtration processes in addition to chlorination treatment.

The filtering membrane in the treatment facility must be backwashed after every 10, 800 litres that pass through it. Each backwash generates approximately 620 litres of wastewater, which is pumped into a wastewater tank that is eventually emptied into the community wastewater pump truck. The treatment plant is equipped with a backup generator so that it can continue to function during a power outage<sup>v</sup>.

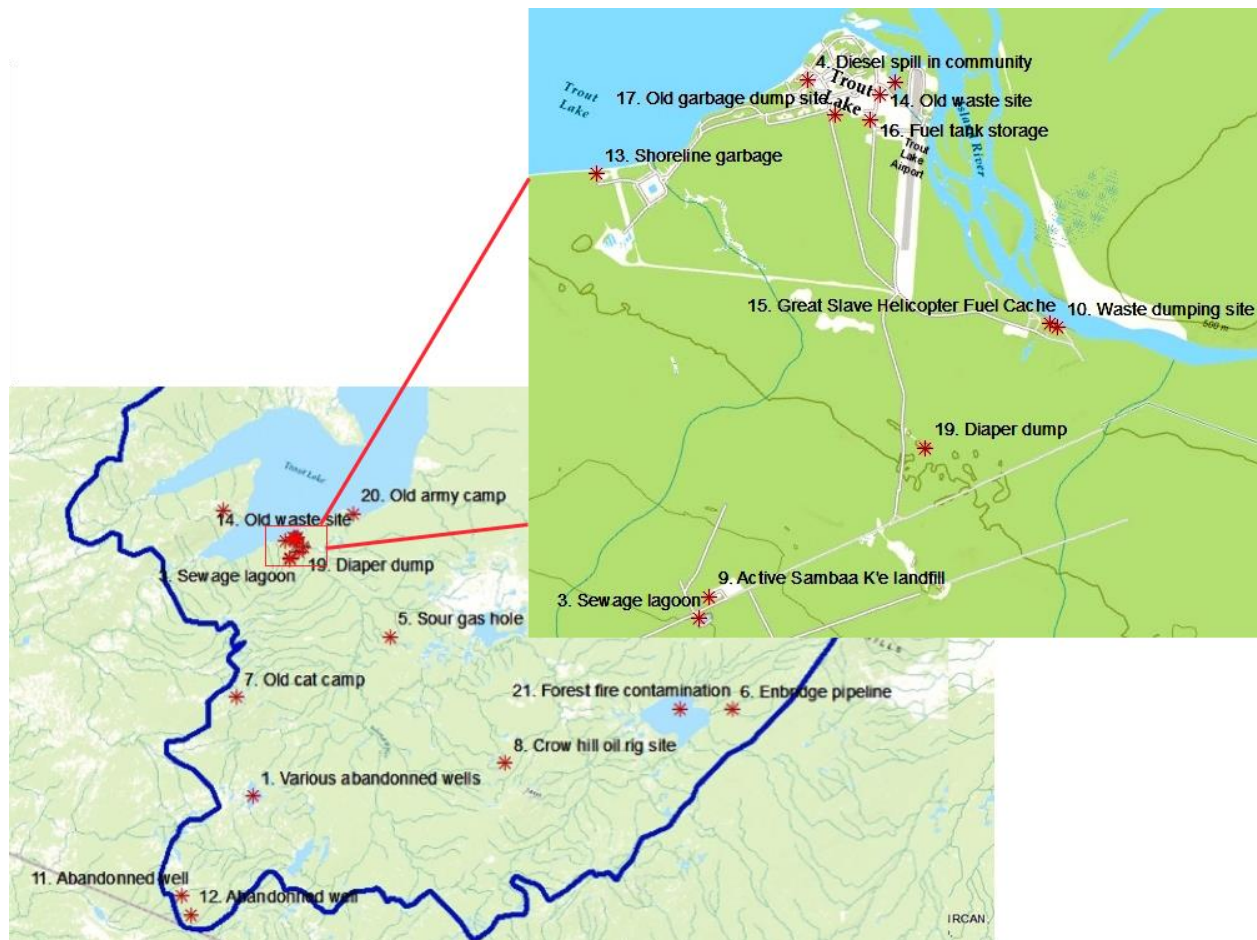
Figure 9: Map of Potential Source Water Contaminant Sources

During the first working group meeting, the working group and community members compiled a list and mapped potential contaminant sources that they felt might be degrading the water quality in Trout Lake (Figure 7). As explained in section 2.2, participants acknowledged that there are potential contaminants that must be documented at both the community and watershed-level. Table 3 provides an inventory of all the potential contaminant sources that community members identified as a risk to the water quality in Trout Lake, including those at both the community and watershed level. The table also provides information about the approximate location of each source, its approximate distance to the nearest shore of Trout Lake, the associated contaminants of concern and the contaminant transport mechanism. The map in Figure 8 indicates the various locations of each potential contaminant source relative to the source water, Trout Lake.
